# **Preliminary Summary Report from Water, Sediment and Fish samples collected at the TVA Ash Spill by Appalachian State University, Appalachian Voices, Tennessee Aquarium and Wake Forest University**

## **Background**

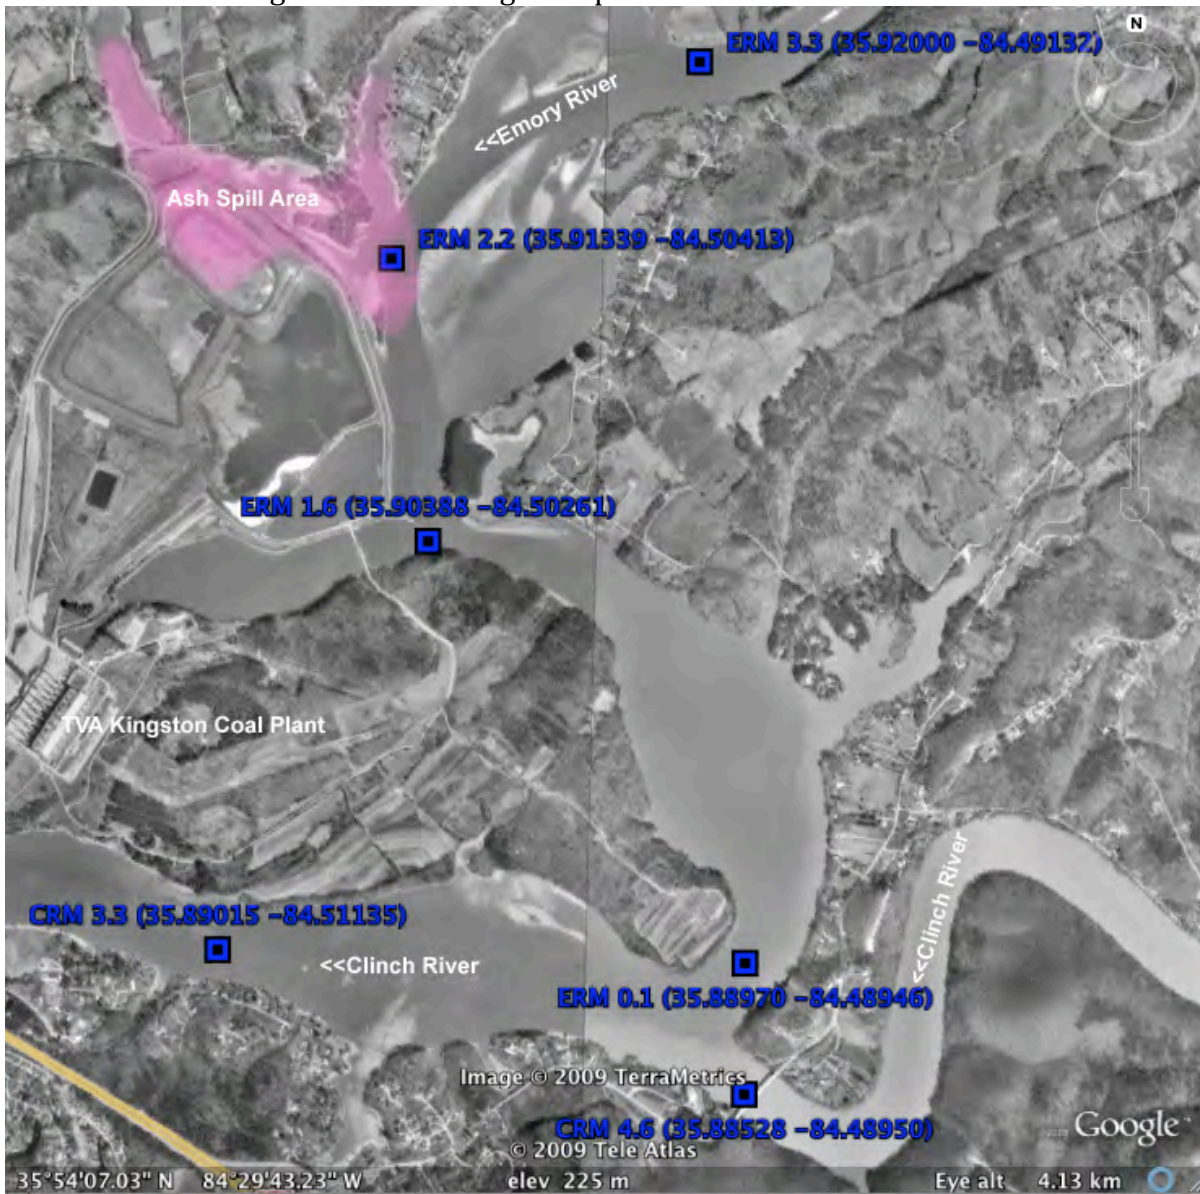
**FIGURE 1.** Appalachian State University /Appalachian Voices/Tennessee Aquarium Sampling Sites January 8 and 9, 2009. Tennessee River sampling location at TRM 567 not depicted.

Seven locations were sampled for 17 elements on the Emory, Clinch and Tennessee Rivers on January 8 and 9, 2009 by a combined team of investigators from Appalachian State University, Appalachian Voices and the Tennessee Aquarium (see Figure 1). Conductivity and dissolved oxygen were collected in the field using a calibrated Orion 5 Star Plus Portable Multimeter. Turbidity was also analyzed in the field using a calibrated Hach 2100P portable turbidimeter that meets ISO 7027 turbidity measurement standards. Grab samples of surface water were collected and analyzed for total and dissolved toxic elements. Sediment samples were collected using an Ekman dredge sampler.

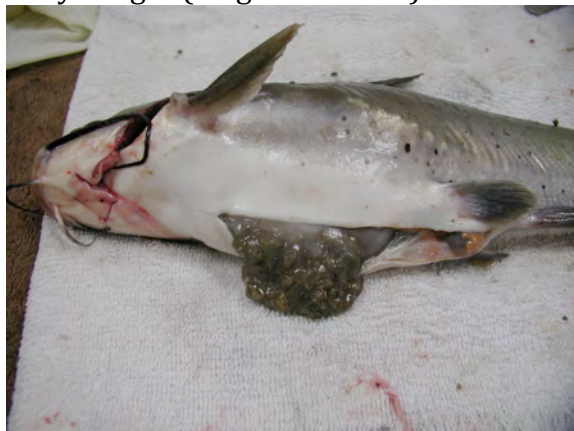
**FIGURE 2.** A channel catfish collected from ERM 2.2 weighed 439 grams and contained 34 grams of ash in the gut, intestines and anal cavity, which means 7.7% of the body weight of the catfish was ash.

**Fish Community Conclusions:** Even with 3 times more shocking seconds at ERM 2.2, the site still had the fewest number of individual fish. In addition, several fish at and downstream of the spill site were observed with scrapes and lost scales. Both are conditions that may be attributed to physical abrasion from ash exposure or to stress from degraded water quality. Figure 2 illustrates that the gut, intestines and anal cavity of one channel catfish was filled with ash that accounted for almost 8% of its body weight (34 grams of ash).
